**Flood Control Project Maintenance
Levee Inspections**
LMA District Cover Sheet
Spring 2019 Levee Inspection Results

Reclamation District No. 0556 Upper Andrus

Spring 2019 Levee Inspection Results

Waterway			Bank	Unit Miles
Unit No. 01 Georgiana Slough			Right	5.48
	Spring (March - May)	Summer (June - August)	(September - November) Fall	Winter (December - February)
Unit Maintenance Rating (Fall Only)				
Date of Inspection	3/21/2019 - 3/21/2019			
DWR Inspector	David Julian			
Accompanied By	Alan Silva Reclamation District 556

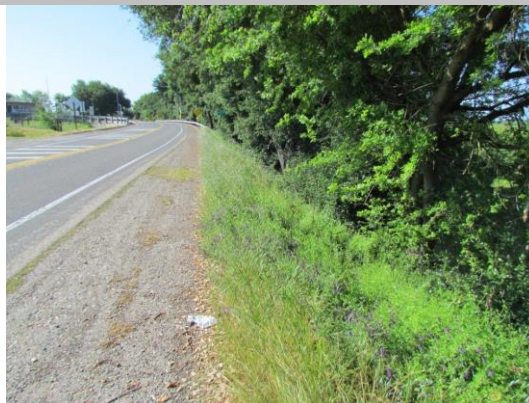
Photo 1 of 1 : SP_2019_RD0556_18_21_20190311_00002.jpg

Looking downstream from levee mile 0.09 woody tree growth and wild weeds covering the levee slope and shoulder landside levee section.

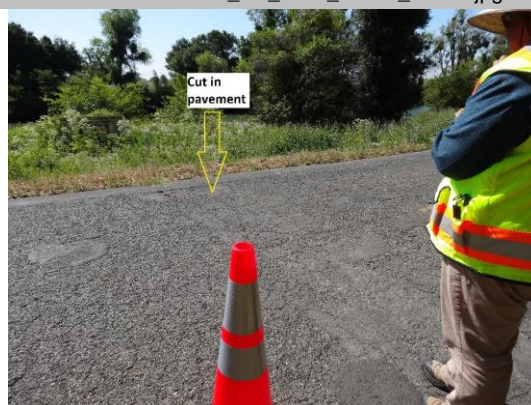
Photo 2 of 3 : UCIP_SP_2019_45564_74146.jpg

Comment Code					
Inspector Comment					
FS_ID:45564 DS_ID:20820 EP_NO: 3448 Repair Type: Non-Urgent Crossing Status: Indicator Found UCIP Comments: Dense vegetation inhibited visibility of gasline marker on WS. Need to contact owner to determine status of crossing. FIELD_STRUCT_DESC: 4.5-inch steel natural gas pipeline through the levee, 4 feet below the crown. Location marker on the waterside (WS) shoulder. Cut in pavement visible at the crossing. Gas line marker on the landside (LS) and on the opposite bank at Reclamation District No. 263 (RD0263). Pipe not located in February 1991. (Plans for construction of a 4.5-inch gas line across Georgiana Slough from Andrus Island to Tyler Island authorized under Permit No. 3448, 1960 - Pacific Gas and Electric Company [PG&E]). [Additional Reference(s): DWR Levee Log]. FS Date: 5/27/2015

View of WS; cut in pavement in alignment with arrow and Olivia indicating location of crossing trench.

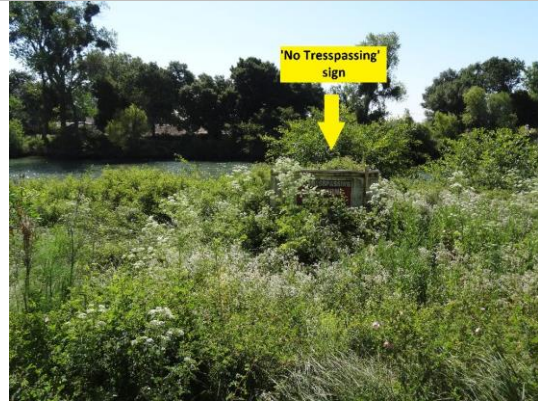
Photo 3 of 3 : UCIP_SP_2019_45564_74152.jpg

Comment Code						
Inspector Comment						
FS_ID:45564 DS_ID:20820 EP_NO: 3448 Repair Type: Non-Urgent Crossing Status: Indicator Found UCIP Comments: Dense vegetation inhibited visibility of gasline marker on WS. Need to contact owner to determine status of crossing. FIELD_STRUCT_DESC: 4.5-inch steel natural gas pipeline through the levee, 4 feet below the crown. Location marker on the waterside (WS) shoulder. Cut in pavement visible at the crossing. Gas line marker on the landside (LS) and on the opposite bank at Reclamation District No. 263 (RD0263). Pipe not located in February 1991. (Plans for construction of a 4.5-inch gas line across Georgiana Slough from Andrus Island to Tyler Island authorized under Permit No. 3448, 1960 - Pacific Gas and Electric Company [PG&E]). [Additional Reference(s): DWR Levee Log]. FS Date: 5/27/2015

View of WS. Dense vegetation limited visibility of 'No Trespassing' sign.

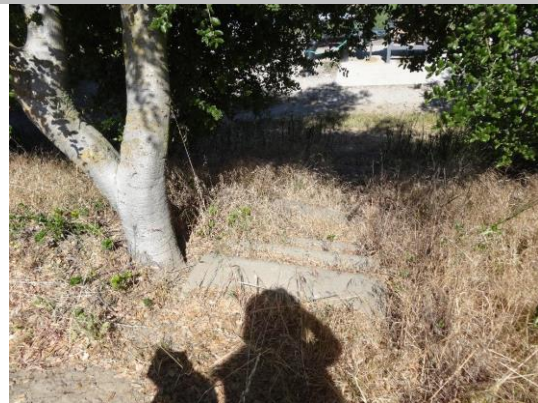
Photo 1 of 3 : UCIP_SP_2019_45663_74180.jpg

Comment Code					
Inspector Comment					
FS_ID:45663 DS_ID:20821 EP_NO: 5548 Repair Type: Non-Urgent Crossing Status: Found UCIP Comments: Dense vegetation prevents inspection of WS slope. FIELD_STRUCT_DESC: 12-inch steel irrigation discharge pipe through the levee, 5 feet below the crown. 1.25-inch electrical conduit through the levee at the same location. Pump on the waterside (WS). Concrete steps on the landside (LS) slope. Cuts in pavement visible at the crossing. (Plans to install a pump with a 12-inch discharge pipe and one electrical conduit through the levee authorized under Permit No. 5548, 1966 - George K. Adams). [Additional Reference(s): DWR Levee Log]. FS Date: 5/13/2015

Concrete steps on LS slope.

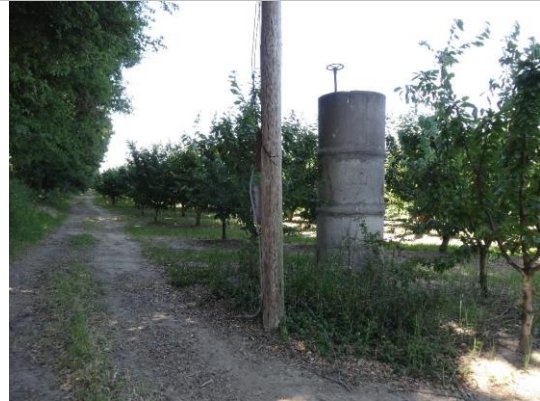
Photo 3 of 3 : UCIP_SP_2019_45664_74192.jpg

Comment Code						
Inspector Comment						
FS_ID:45664 DS_ID:20826 EP_NO: 5548A Repair Type: Non-Urgent Crossing Status: Found UCIP Comments: Dense vegetation prevented inspection of WS slope. FIELD_STRUCT_DESC: 14-inch steel irrigation discharge pipe through the levee, 5 feet below the crown. Pump on the waterside (WS). Electrical conduit through the levee at the same location. Pole with electrical panel at the landside (LS) toe. Standpipe at the LS toe. (Plans to install a 7-gauge, 14-inch pipe through the levee authorized under Permit No. 5548-A, 1981 - Kaydix Company). [Additional Reference(s): DWR Levee Log]. FS Date: 5/27/2015

Standpipe and service pole visible off LS toe.

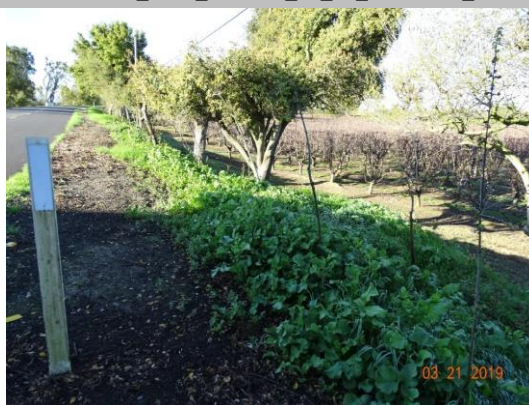
Photo 1 of 1 : SP_2019_RD0556_18_19_20190321_00072.jpg

View looking downstream at vegetation on the landside shoulder and slope (Spring 2019).

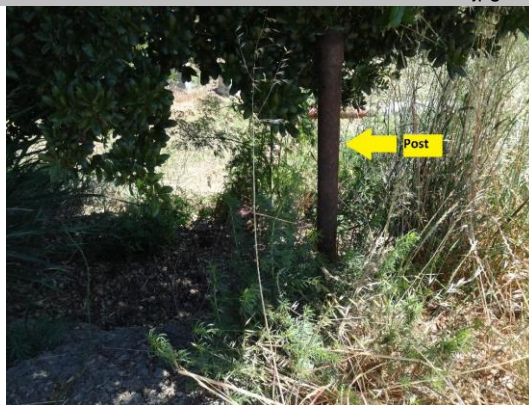
Photo 2 of 3 : UCIP_SP_2019_46799_74740.jpg

LM Start	1.17	Rating **	M	Issue No.	52
LM End	1.17	Issue Type +	En	Location *	
Category	Supplemental			GPS Latitude/Longitude	
				Start	End
Item	DWR UCIP Field Study			38.227534 °	38.227534 °
				-121.529396 °	-121.529396 °
DWR ID	25106				
Comment Code					
Inspector Comment					
FS_ID:46799 DS_ID:25106 EP_NO: N/A Repair Type: Non-Urgent Crossing Status: Found UCIP Comments: Possible erosion above pipe on LS needs attention. FIELD_STRUCT_DESC: 8-inch steel irrigation pipe through the levee, at an unknown depth. Visible on the landside (LS), 6 feet away from the 10-inch pipe at HLM 1.17. Post likely for protection of vent located on the shoulder. Power pole next to pipe on the LS. This crossing was field discovered. FS Date: 5/27/2015

LS view: Post located above pipe on LS slope.

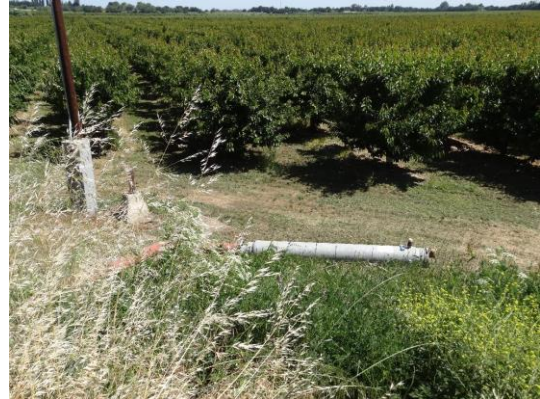
Photo 3 of 3 : UCIP_SP_2019_46799_74741.jpg

LM Start	1.17	Rating **	M	Issue No.	52 (cont)	
LM End	1.17	Issue Type +	En	Location *		
Category	Supplemental			GPS Latitude/Longitude		
				Start	End	
Item	DWR UCIP Field Study			38.227534 °	38.227534 °	
				-121.529396 °	-121.529396 °	
DWR ID	25106					
Comment Code						
Inspector Comment						
FS_ID:46799 DS_ID:25106 EP_NO: N/A Repair Type: Non-Urgent Crossing Status: Found UCIP Comments: Possible erosion above pipe on LS needs attention. FIELD_STRUCT_DESC: 8-inch steel irrigation pipe through the levee, at an unknown depth. Visible on the landside (LS), 6 feet away from the 10-inch pipe at HLM 1.17. Post likely for protection of vent located on the shoulder. Power pole next to pipe on the LS. This crossing was field discovered. FS Date: 5/27/2015

Electric pole next to pipe on LS.

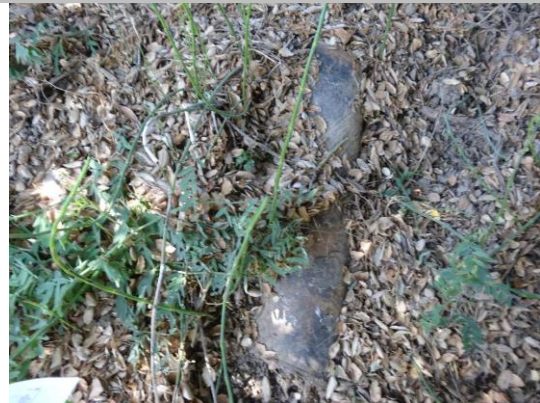
Photo 1 of 3 : UCIP_SP_2019_45683_74200.jpg

Comment Code						
Inspector Comment						
FS_ID:45683 DS_ID:20823 EP_NO: 11169 Repair Type: Non-Urgent Crossing Status: Found UCIP Comments: Appears abandoned in place and if so should be done so properly. Dense vegetation on WS limits visibility. FIELD_STRUCT_DESC: *ABANDONED* 10-inch steel irrigation discharge pipe through the levee, 3.8 feet below the crown. Located at the lower end of the rock revetment. (Plans to replace an existing 10-inch suction pipe with a 10-inch slant propeller pump on the levee authorized under Permit No. 4848, 1965 - Kay Dix Ranch Company. Retention of a 10-inch pipe through the levee, 3.8 feet below the crown, authorized under Automatic Board Order (ABO) issued as Permit No. 11169, 1975 - Darrell T. and B. M. Mealer). Abandoned in place. [Additional Reference(s): DWR Levee Log. USACE Sacramento O&M Manual 103, June 1954, (Station ""R"" 548+59.8), invert elevation 16.8 feet]. FS Date: 5/27/2015

LS view of pipe appearing abandoned in place.

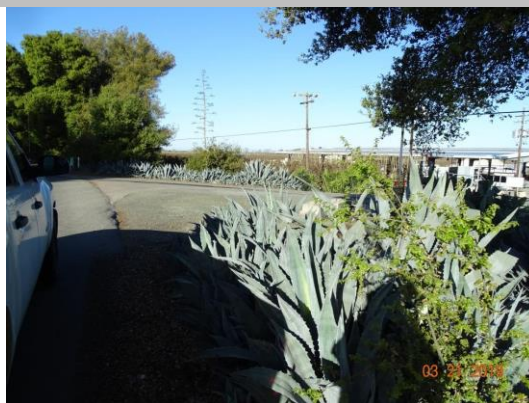
Photo 1 of 1 : SP_2019_RD0556_18_45_20190321_00074.jpg

View of cactus on the landside shoulder (Spring 2019).

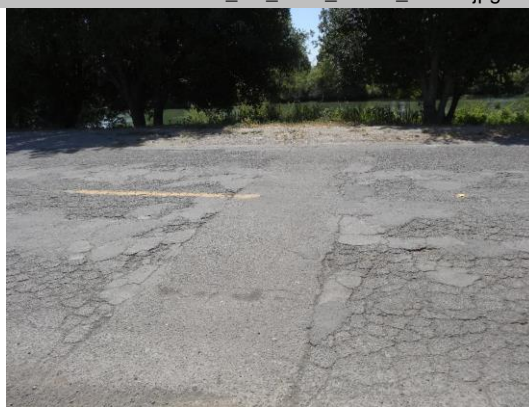
Photo 2 of 3 : UCIP_SP_2019_45692_74205.jpg

WS view and cuts visible on pavement.

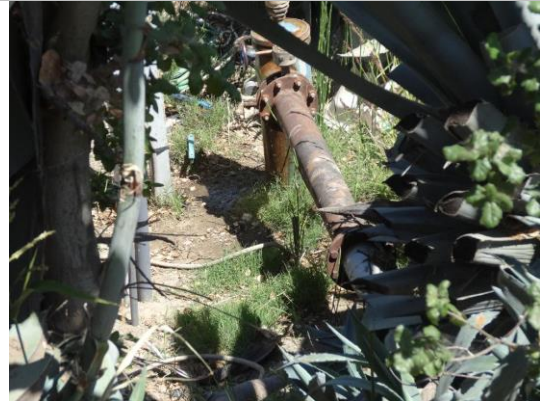
Photo 3 of 3 : UCIP_SP_2019_45692_74206.jpg

Comment Code						
Inspector Comment						
FS_ID:45692 DS_ID:20825 EP_NO: 13302 Repair Type: Non-Urgent Crossing Status: Found UCIP Comments: Seal beneath siphon breaker off LS toe leaking. Rodent activity near crown off LS shoulder. Need to contact owner about leaky seal. Dense vegetation prevented inspection of WS slope. FIELD_STRUCT_DESC: 6-inch steel irrigation discharge pipe and 2-inch galvanized iron electrical conduit through the levee, 2 feet below the crown. Siphon valve on the landside (LS) shoulder. Concrete stand and pump at the LS toe. Circuit box also at the LS toe. Cuts visible in pavement. 6-inch polyvinyl chloride (PVC) standpipe adjacent to the pipe off the LS toe. (Plans to install a 6-inch irrigation pipe and electrical conduit through the levee authorized under Permit No. 13302, 1981 - Kaydix Ranch). [Additional Reference(s): DWR Levee Log. USACE Sacramento O&M Manual 103, June 1954, (Station ""R"" 540+85), invert elevation 16.3 feet]. FS Date: 5/27/2015

Closeup of pipe at LS toe. Seal beneath siphon breaker leaking.

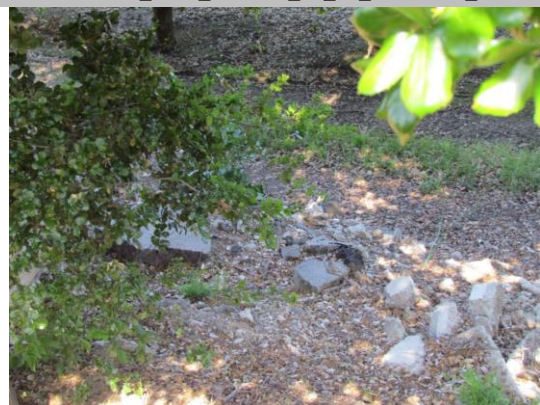
Photo 1 of 3 : SP_2019_RD0556_18_27_20190311_00009.jpg

RD 556 Unit 1 levee mile 1.34-1.37 landside toe.

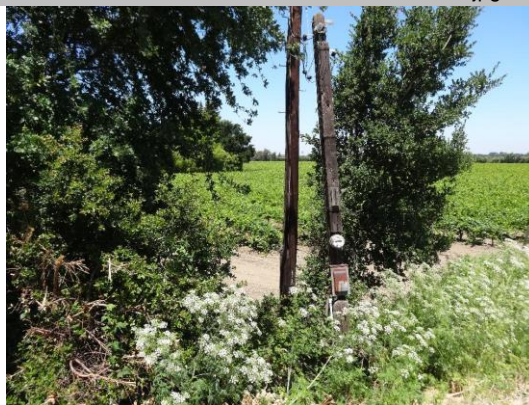
Photo 2 of 3 : UCIP_SP_2019_45764_74261.jpg

Comment Code						
Inspector Comment						
FS_ID:45764 DS_ID:20829 EP_NO: 11178 Repair Type: Non-Urgent Crossing Status: Found UCIP Comments: Dense vegetation on WS and LS. Some oil leakage inside pumphouse. FIELD_STRUCT_DESC: 8-inch steel irrigation discharge pipe through the levee, 3.7 feet below the crown. 2-inch electrical conduit through the levee, next to the 8-inch discharge pipe. 1-inch air valve and pump on the waterside (WS) berm. Service pole on the landside (LS) slope. Tin and wood pump house on the WS berm. 12-foot by 3-foot concrete standpipe on the LS. (Retention of an 8-inch pipe through the levee, 3.7 feet below the crown, a pump on the WS berm, and a service pole on the LS slope authorized under Automatic Board Order (ABO) issued as Permit No. 11178, 1975 - Allena D. Swett). [Additional Reference(s): DWR Levee Log. USACE Sacramento O&M Manual 103, June 1954, (Station ""R"" 511+00), invert elevation 16.4 feet]. FS Date: 5/27/2015

Pole on LS slope with electric box and 2-inch conduit.

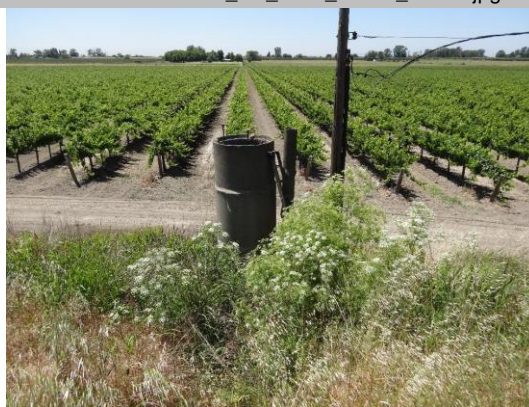
Photo 3 of 3 : UCIP_SP_2019_45786_74282.jpg

LS: 2 standpipes and service pole.

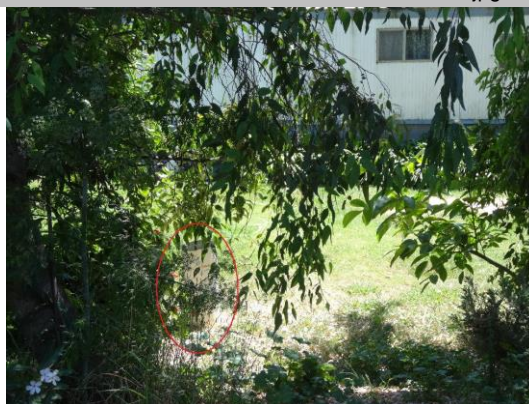
Photo 2 of 3 : UCIP_SP_2019_52734_74288.jpg

Concrete standpipe off LS toe.

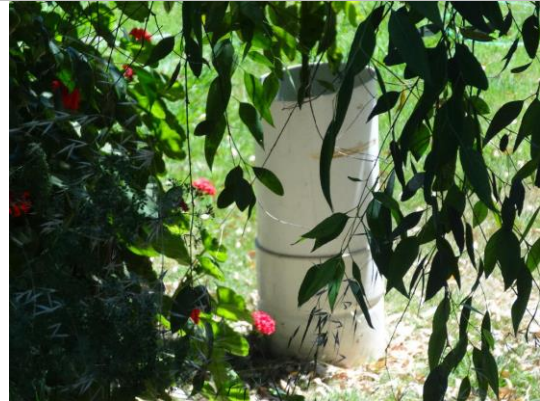
Photo 3 of 3 : UCIP_SP_2019_52734_74289.jpg

Closeup of concrete standpipe off LS toe.

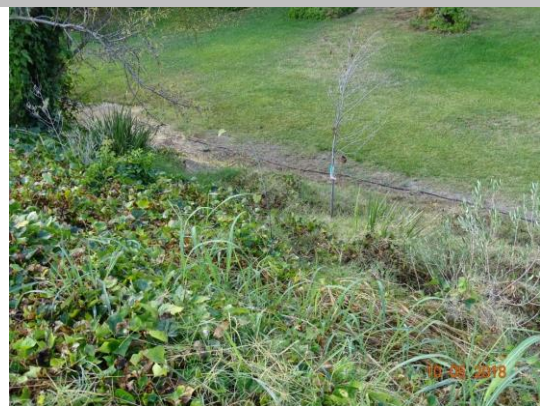
Photo 1 of 1 : SP_2019_RD0556_18_26_20190311_00008.jpg

Newly planted tree on the land side slope (October 2018).

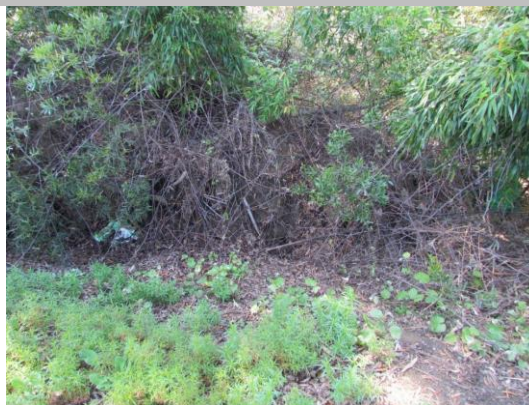
Photo 2 of 2 : SP_2019_RD0556_18_33_20190311_00018.jpg

RD 556 Unit 1 levee mile 2.72 the root ball of the fallen tree on slope landward.

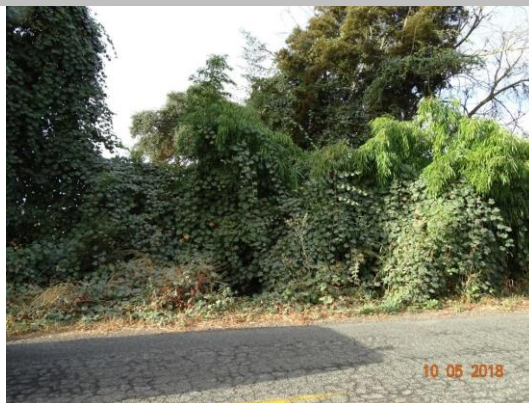
Photo 1 of 1 : SP_2019_RD0556_18_48_20190322_00075.jpg

View of wild grapes and bamboo on the landside slope (Fall 2018).

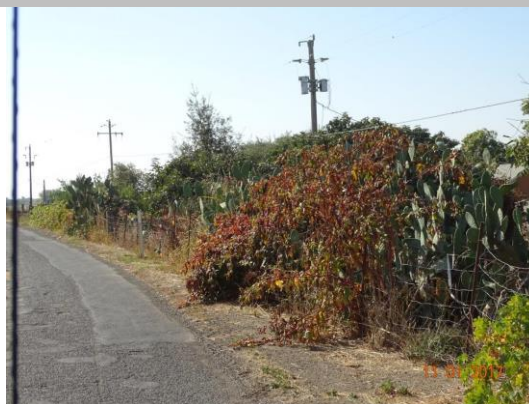
Photo 1 of 1 : SP_2019_RD0556_18_29_20190311_00013.jpg

View of large cactus growing on shoulder and slope

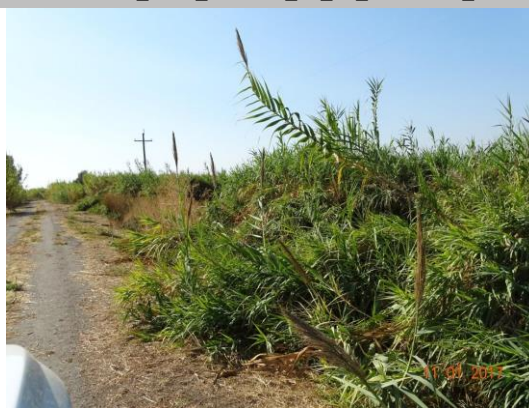
Photo 1 of 1 : SP_2019_RD0556_18_39_20190311_00023.jpg

View of dense growth of wild vegetation, berry vines and arundo on landside slope and toe

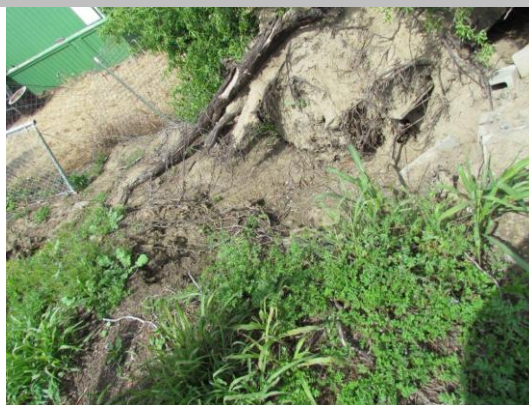
Photo 1 of 2 : SP_2019_RD0556_18_44_20190311_00025.jpg

RD 556 Unit 1 levee mile 5.46 fallen tree on landside slope and damage to the slope.

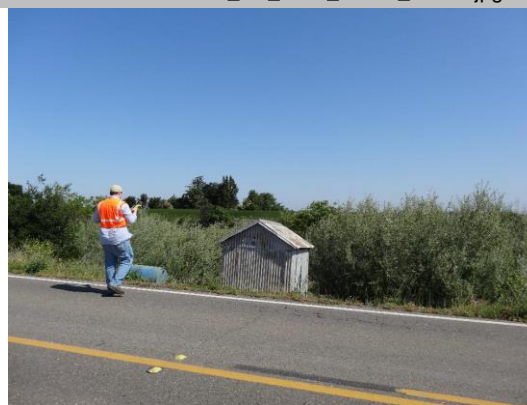
Photo 1 of 3 : UCIP_SP_2019_12512_20245.jpg

WS- pump house on levee berm

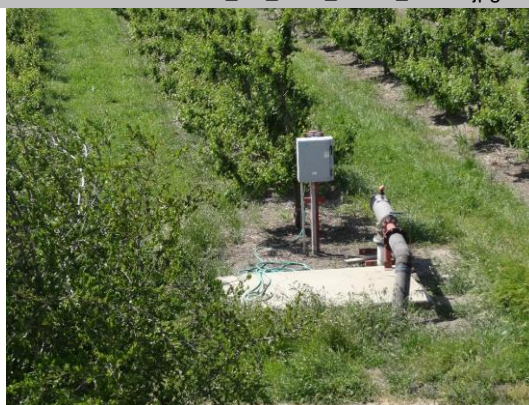
Photo 1 of 3 : UCIP_SP_2019_12573_20381.jpg

LS- 6-inch steel pipe on orchard.

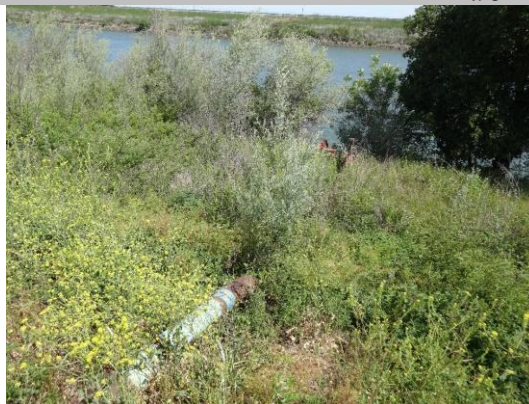
Photo 3 of 3 : UCIP_SP_2019_12573_20383.jpg

WS- 6-inch steel pipe on levee slope

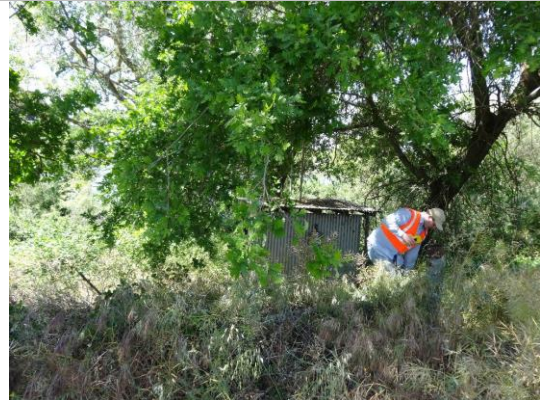
Photo 1 of 3 : UCIP_SP_2019_12574_20388.jpg

WS- pump house on levee berm

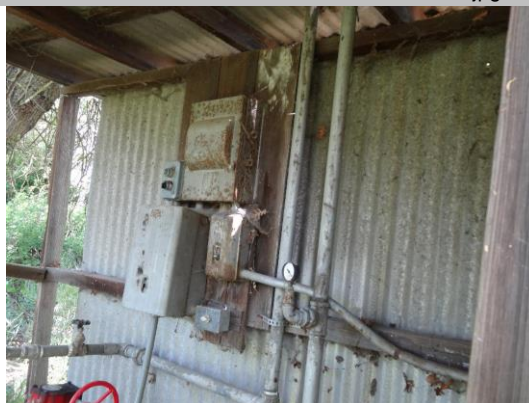
Photo 3 of 3 : UCIP_SP_2019_12574_20386.jpg

WS- power control panel and electric conduit in pump house.

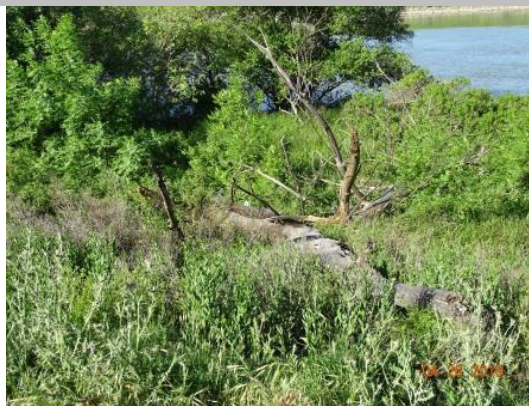
Photo 1 of 1 : SP_2019_RD0556_19_44_20190429_00086.jpg

View of fallen tree within 20' of the waterside shoulder (Spring 2019).

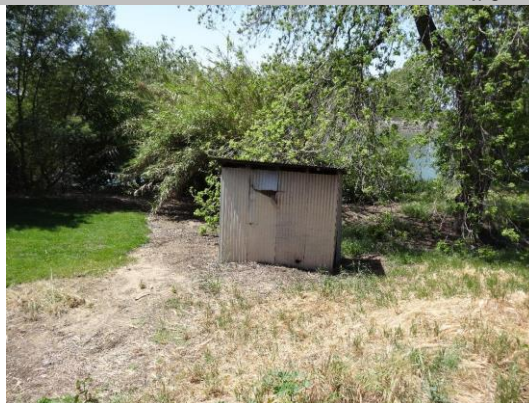
Photo 1 of 3 : UCIP_SP_2019_41713_20284.jpg

WS- pump house on levee berm.

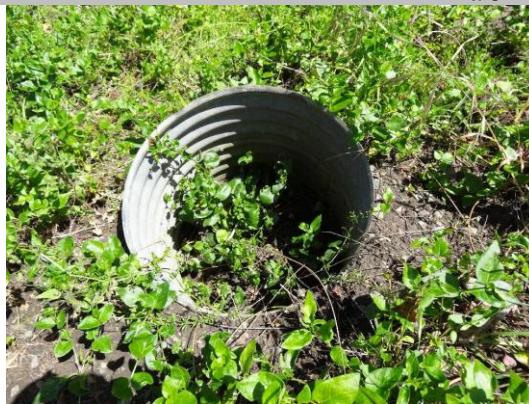
Photo 2 of 3 : UCIP_SP_2019_41713_20283.jpg

LS- siphon breaker in CMP riser on levee slope.

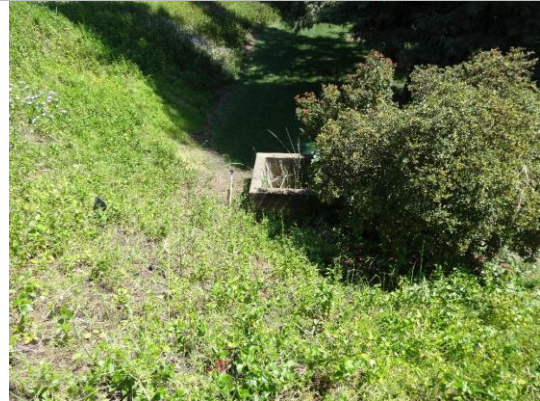
Photo 3 of 3 : UCIP_SP_2019_41713_20282.jpg

LS- concrete distribution box near toe of the levee

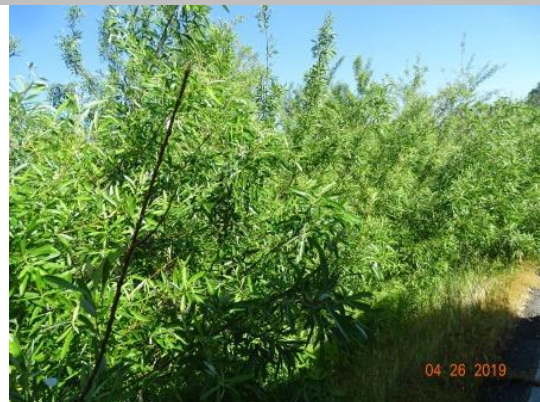
Photo 1 of 2 : SP_2019_RD0556_19_76_20190429_00088.jpg

View looking upstream at thick wildgrowth on the waterside slope (Spring 2019).

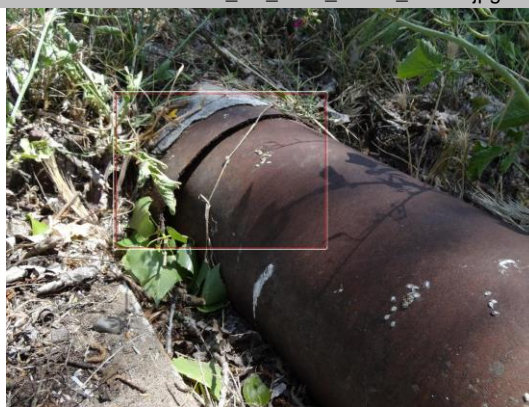
Photo 2 of 3 : UCIP_SP_2019_12525_20289.jpg

WS- 9-inch pipe sleeved through 10 inch steel pipe.

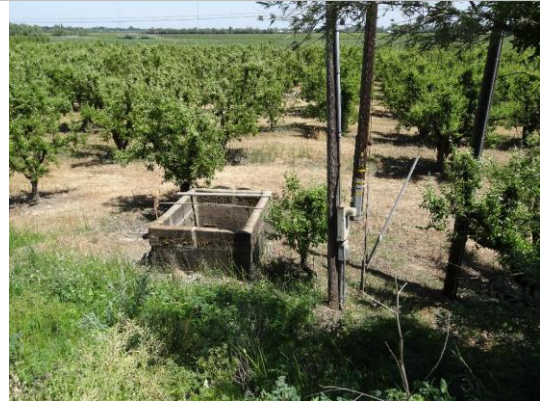
Photo 3 of 3 : UCIP_SP_2019_12525_20288.jpg

LS- a concrete spill box on landside of the levee.

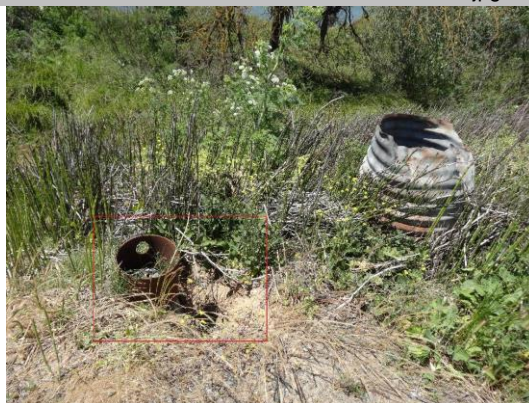
Photo 2 of 3 : UCIP_SP_2019_12527_20296.jpg

WS- siphon breaker and abandoned CMP riser laying adjacent to it.

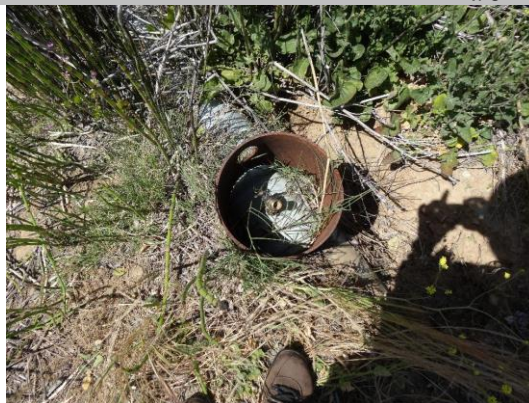
Photo 3 of 3 : UCIP_SP_2019_12527_20295.jpg

WS- siphon breaker on levee slope.

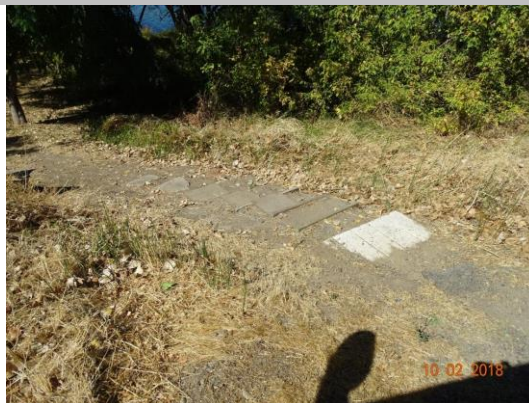
Photo 1 of 1 : SP_2019_RD0556_19_78_20190311_00037.jpg

View of stairs on waterside slope (October 2018).

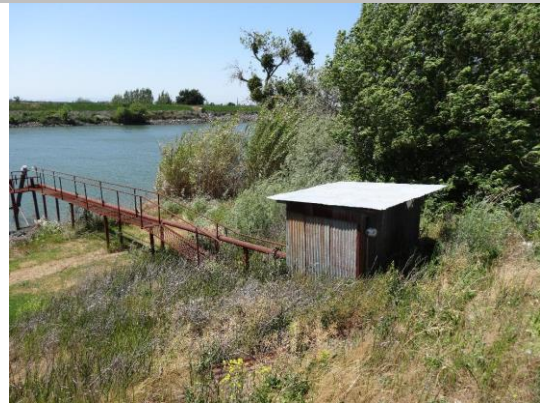
Photo 1 of 3 : UCIP_SP_2019_12543_20302.jpg

WS- pipe and pump on steel pile structure. Steel walkway from pump house to the pump on steel structure.

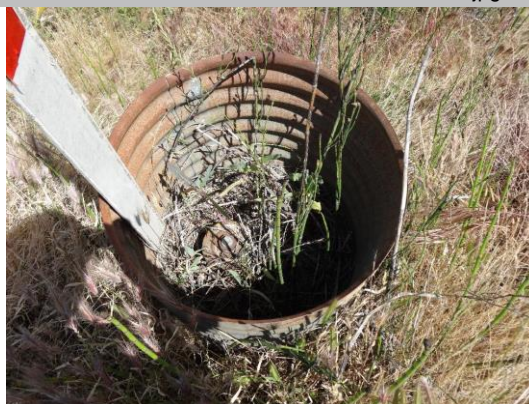
Photo 3 of 3 : UCIP_SP_2019_12543_20300.jpg

LS- siphon breaker in CMP riser. It needs cleaning.

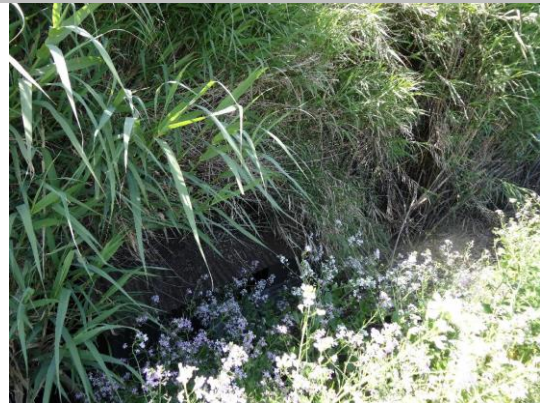
Photo 1 of 3 : UCIP_SP_2019_12545_20310.jpg

WS- pump house not visible due to the dense vegetation.

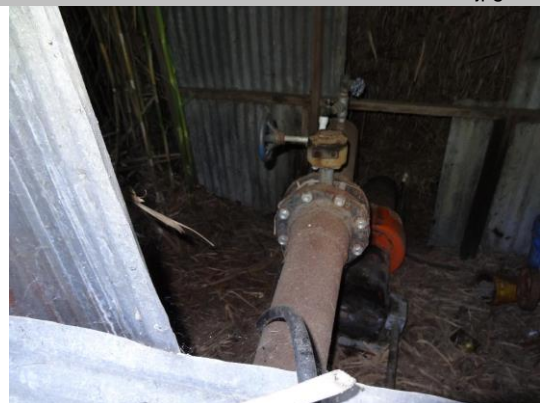
Photo 3 of 3 : UCIP_SP_2019_12545_20308.jpg

WS- pump, gate valve and pipe in pump house.

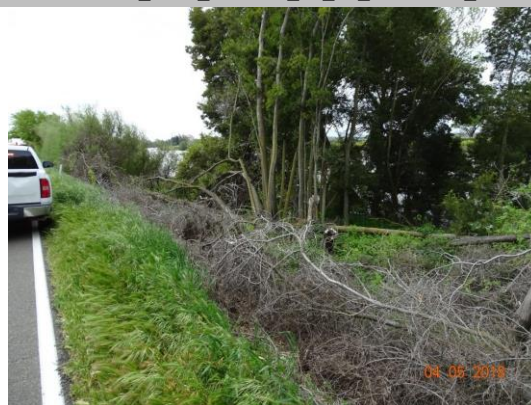
Photo 1 of 1 : SP_2019_RD0556_19_54_20190311_00028.jpg

View of fallen tree and other woody debris on the waterside.

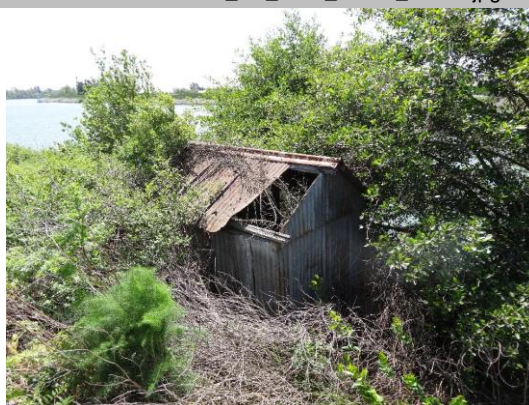
Photo 1 of 3 : UCIP_SP_2019_12546_20314.jpg

WS- abandoned pump house on levee slope. Dense vegetation on levee slope.

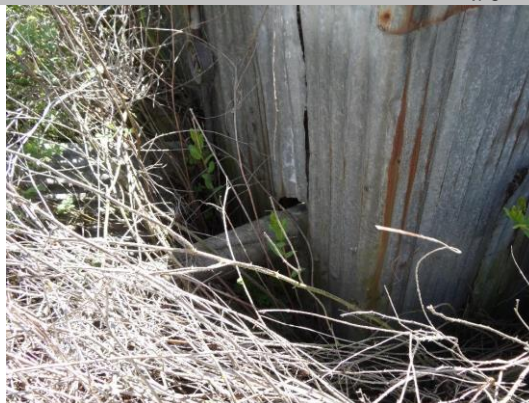
Photo 2 of 3 : UCIP_SP_2019_12546_20313.jpg

WS- pipe daylight from levee slope to pump house.

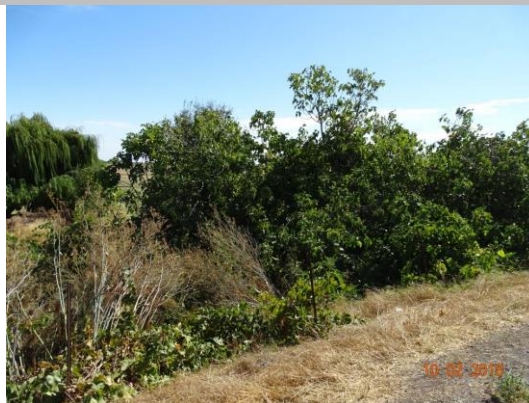
Photo 1 of 1 : SP_2019_RD0556_19_58_20190311_00030.jpg

View of fig tree on landside slope (October 2018).

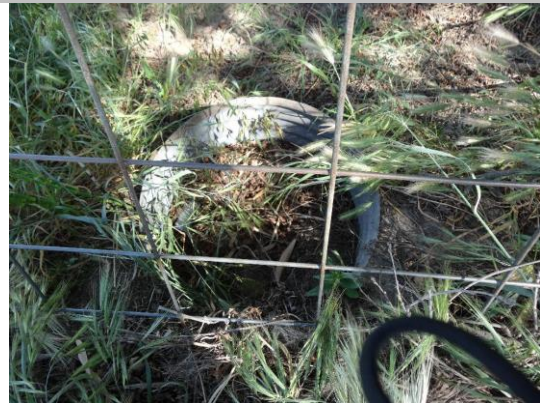
Photo 1 of 3 : UCIP_SP_2019_12547_20320.jpg

LS- obstructed siphon breaker in CMP riser on levee slope.

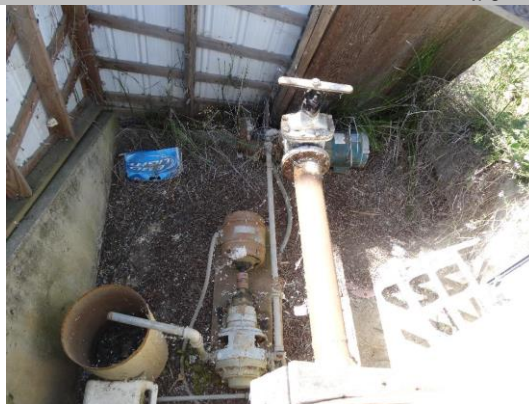
Photo 2 of 3 : UCIP_SP_2019_12564_20346.jpg

WS- pump, pipe and gate valve in pump house.

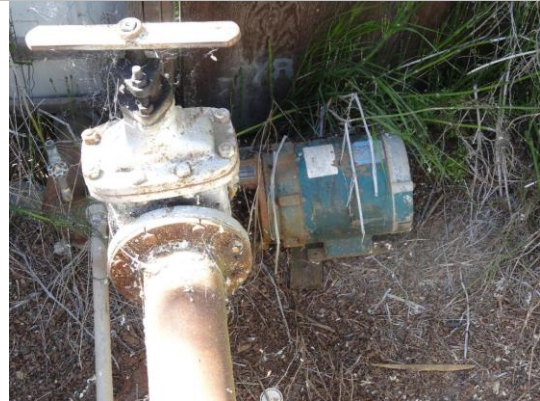
Photo 3 of 3 : UCIP_SP_2019_12564_20351.jpg

WS- closer look at pump, pipe and gate valve in pump house.

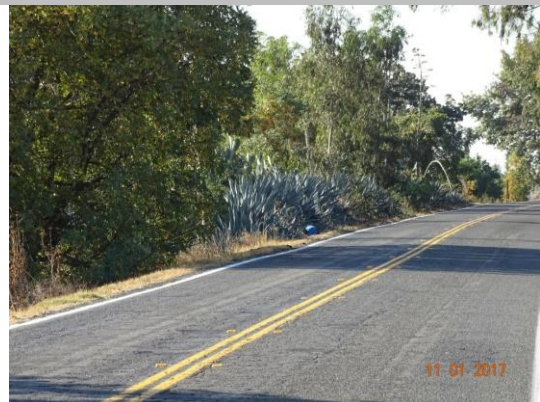
Photo 1 of 1 : SP_2019_RD0556_19_37_20190311_00021.jpg

View of large cactus on the landside slope and toe.

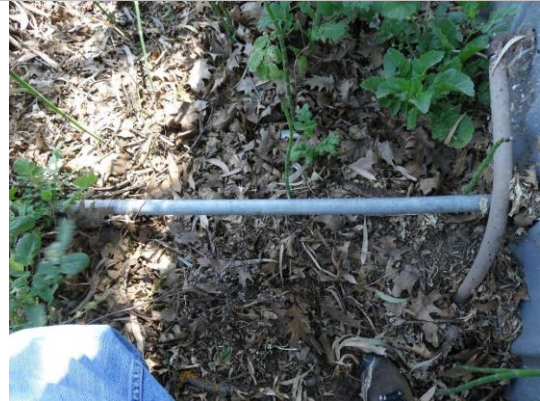
Photo 3 of 3 : UCIP_SP_2019_52733_20366.jpg

WS- electric conduit daylight near pump house.

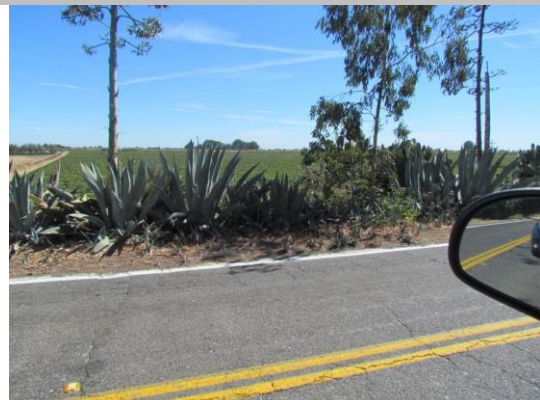
Photo 1 of 1 : SP_2019_RD0556_19_31_20190311_00015.jpg

RD 556 Unit 2 levee mile 5.40-5.44 landside levee shoulder and slope looking downstream.
